Challenges and Innovations in Large-Scale Excavation: Inverted-Method Tunnel under the Rimac River in Lima, Peru

R. Kochen, D.F.M. Melo, I.G.B. Oliveira, R. Araújo, H.G. Jarrouge Neto, T.H.L. Jesus
GeoCompany Tecnologia Engenharia e Meio Ambiente Ltda, Brazil

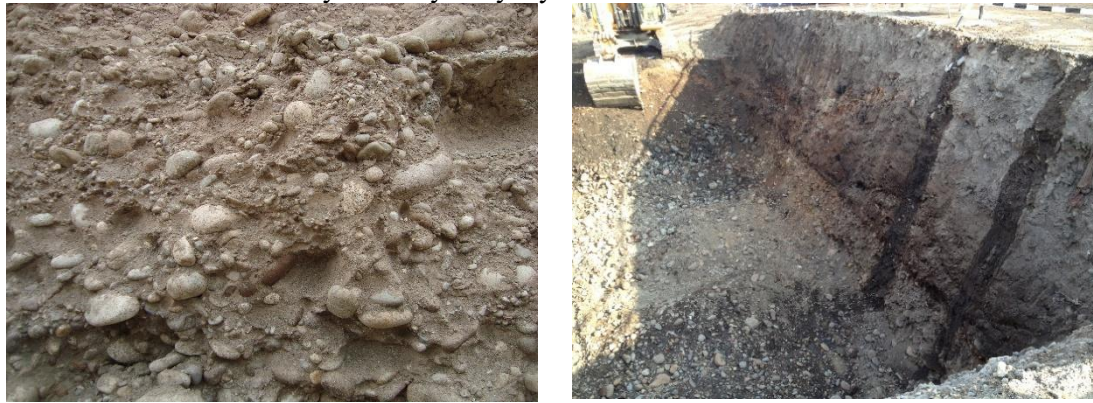
Figure 2. Details of the conglomerate found in the excavation area.

In the area where the project was implemented, the Rímac River crosses Quaternary fluvial deposits, composed predominantly of a conglomerate consisting of rock blocks of variable sizes — generally ranging from 0.15 m to 0.40 m — of igneous or volcanic origin, mainly granitic and andesitic. These blocks are embedded in a sandy-silty matrix, brown to light-brown in color, with occasional interbedded sandy or sandy-silty layers.

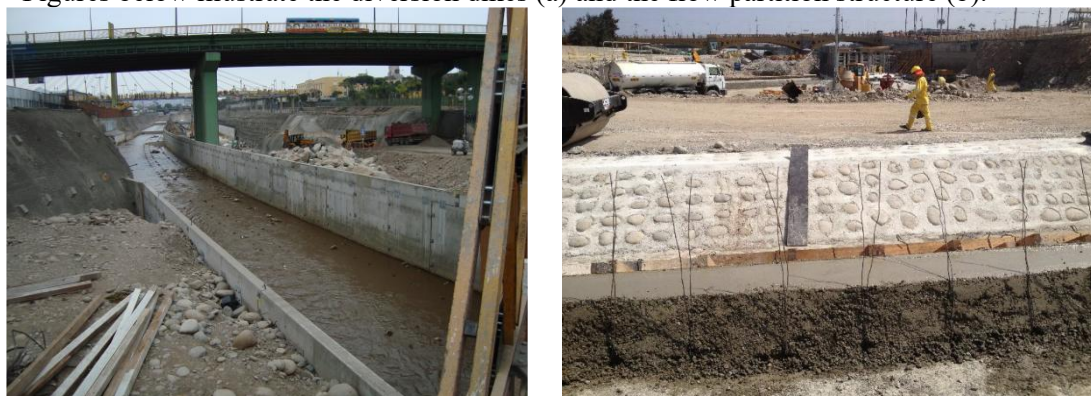
Figure 3. (a) Diversion channel constructed for the works and (b) diversion dike directing the river flow.

Two main dikes were constructed, each with its respective spillway, designed by GeoCompany with the objective of fully diverting the river flow during the dry season. The dikes were built using roller-compacted concrete (RCC), with masonry stone facing and cyclopean concrete sections.

The upstream dike also served to retain rock blocks transported by the current, requiring periodic cleaning to maintain its efficiency. The diversion dike, in turn, was responsible for distributing the flow between the provisional channel and the natural riverbed, depending on the discharge regime.

Figures below illustrate the diversion dikes (a) and the flow partition structure (b).

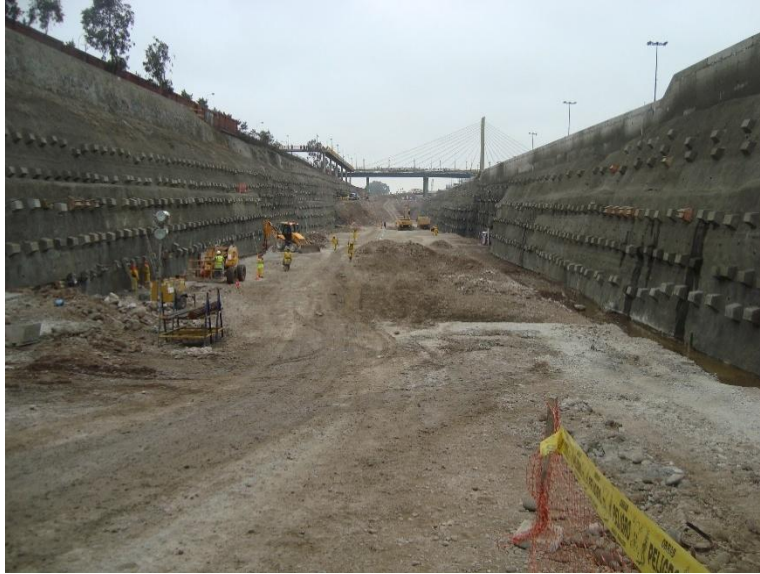
Figure 4. View of the slope excavation along the construction site.

For the slopes, which reached an approximate height of 14 meters, different stabilization alternatives were evaluated, and the solution adopted consisted of soil nailing, combined with active (tieback) and passive (self-drilling) anchors.

The initial stabilization system consisted of a 17 cm-thick shotcrete layer, reinforced with two layers of steel mesh, associated with passive anchors arranged in a variable grid (1.5 to 3.0 m horizontally and 2.0 m vertically).

Although the laboratory cohesion values were relatively low, the slopes remained stable during excavation, showing only slight wind erosion over time. This stability was attributed to the natural cementation of the sandy matrix of the conglomerate and the presence of apparent cohesion.

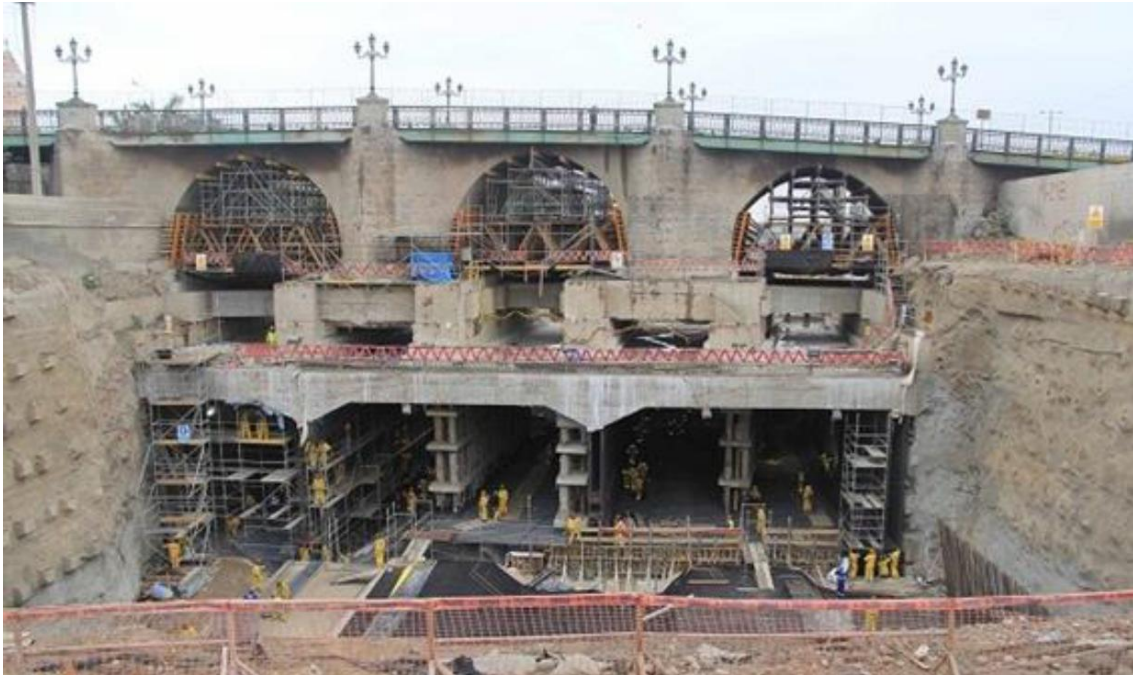
Figure 6. Tunnel construction beneath the historic stone bridge.

During construction, interferences were identified with existing bridges founded on shallow foundations, including a century-old masonry arch bridge of historical significance.

In such cases, reinforcement and underpinning solutions were developed using reinforced concrete micropiles, supported by special foundation blocks individually designed for each pier, ensuring the preservation of the existing structures.

The following figure illustrates an example of an executed footing.
